## PHASE IB ARCHEOLOGICAL INVESTIGATION

### Regeneron Tempel Lane Campus and North Utility Corridor

Tempel Lane and 3<sup>rd</sup> Avenue  
Town of East Greenbush  
Rensselaer County, New York

January 2017

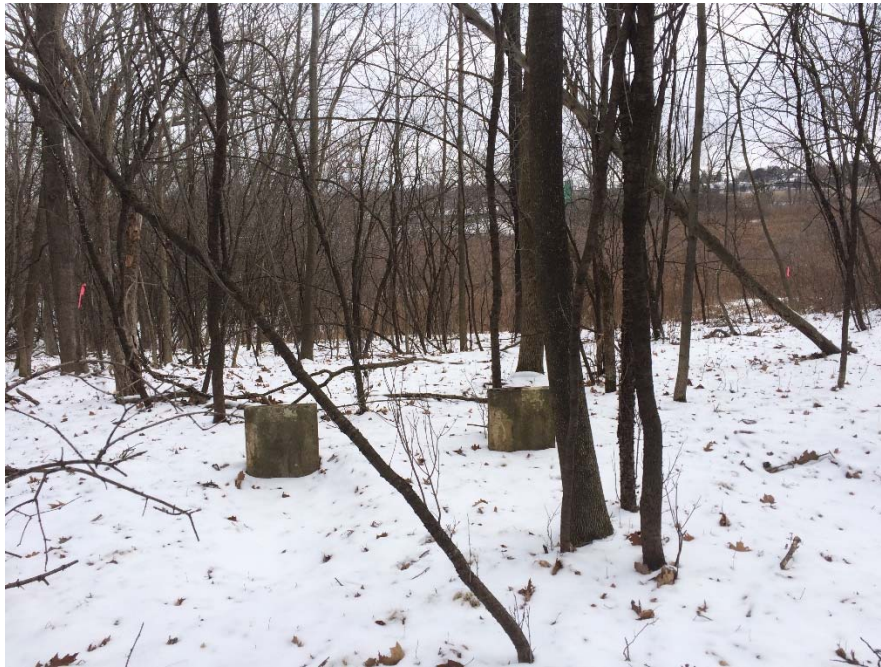
**Photo 1:** View east of a cluster of gravestones situated east of the construction easement. The gravestones were located near the eastern end of the cemetery road that traverses the south end of the property.

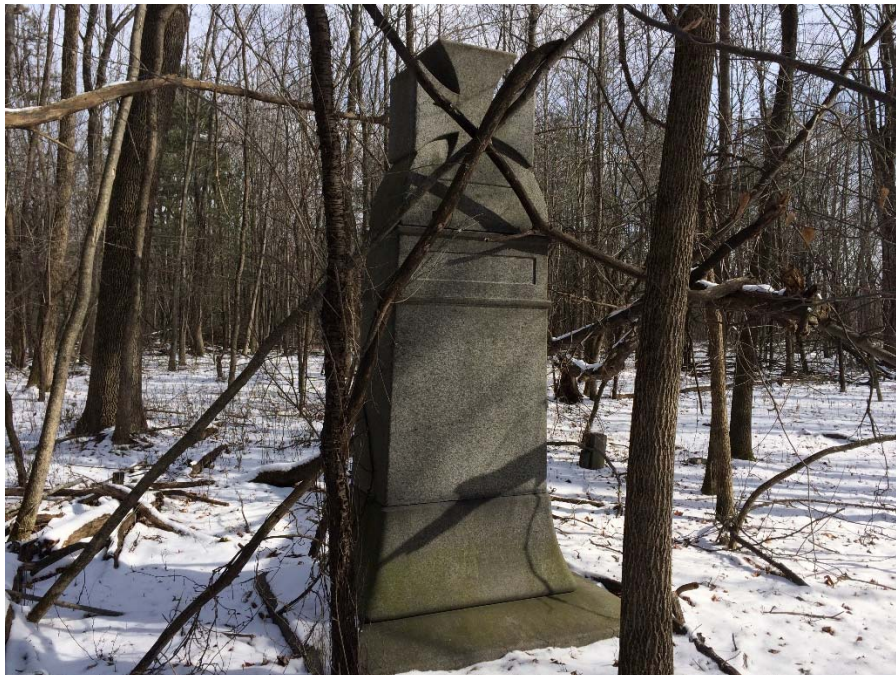
**Photo 2:** View west of a cluster of gravestones situated west of the construction easement. The gravestones were located north of the cemetery road that traverses the south end of the property.

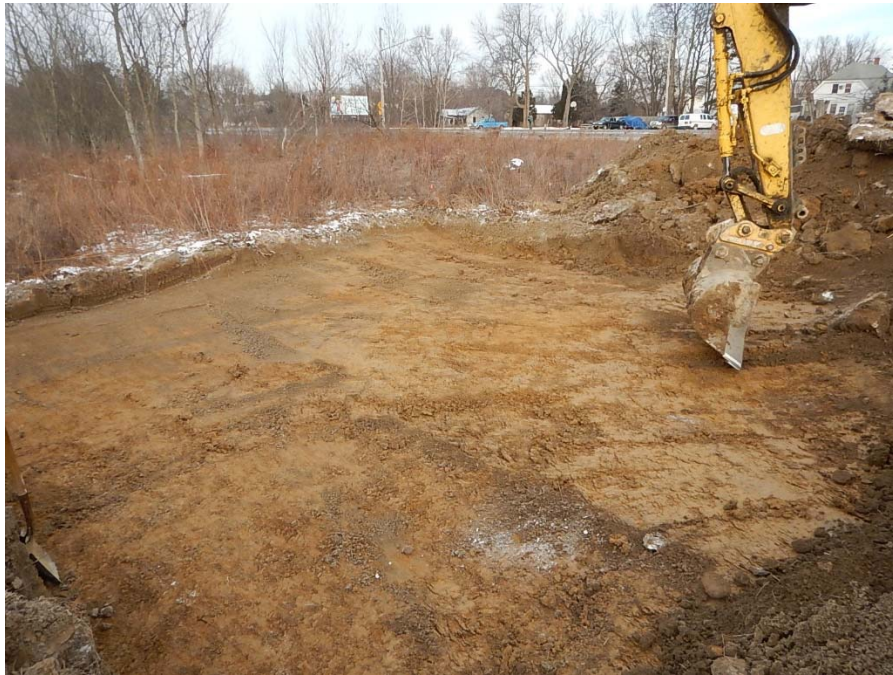
**Photo 3:** View northwest of Area 1 located at the north end of the construction easement. The 10 by 10 meter area lies adjacent to one of the cemetery roads shown on the New Rural Cemetery Concept Plan c. 1900. No burial shafts were encountered within the Stratum 2 subsoil.

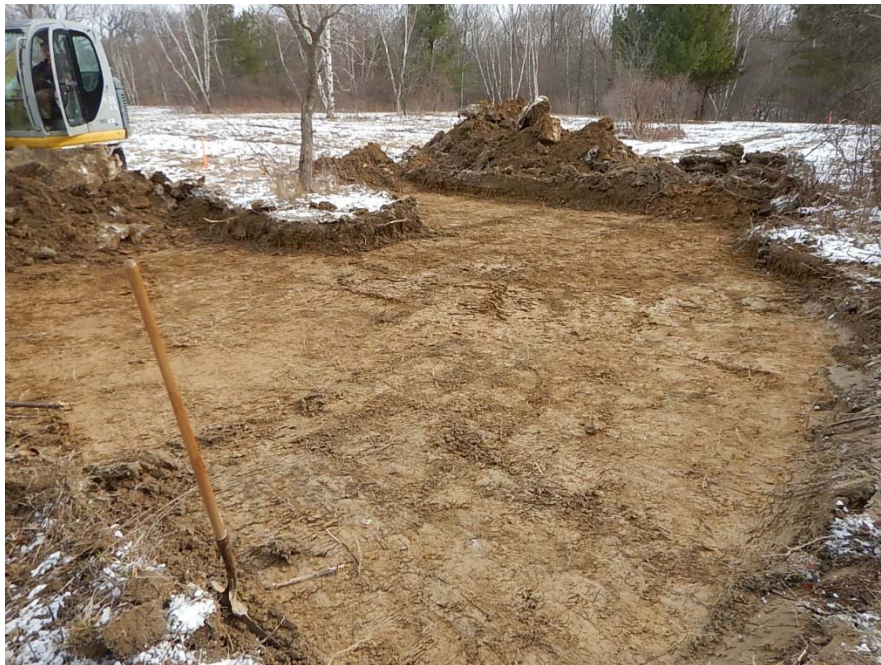
**Photo 4:** View southeast of Area 2 located at the north end of the construction easement. The 10 by 10 meter area was excavated adjacent to one of the cemetery roads shown on the New Rural Cemetery Concept Plan c. 1900. No burials shafts were identified.

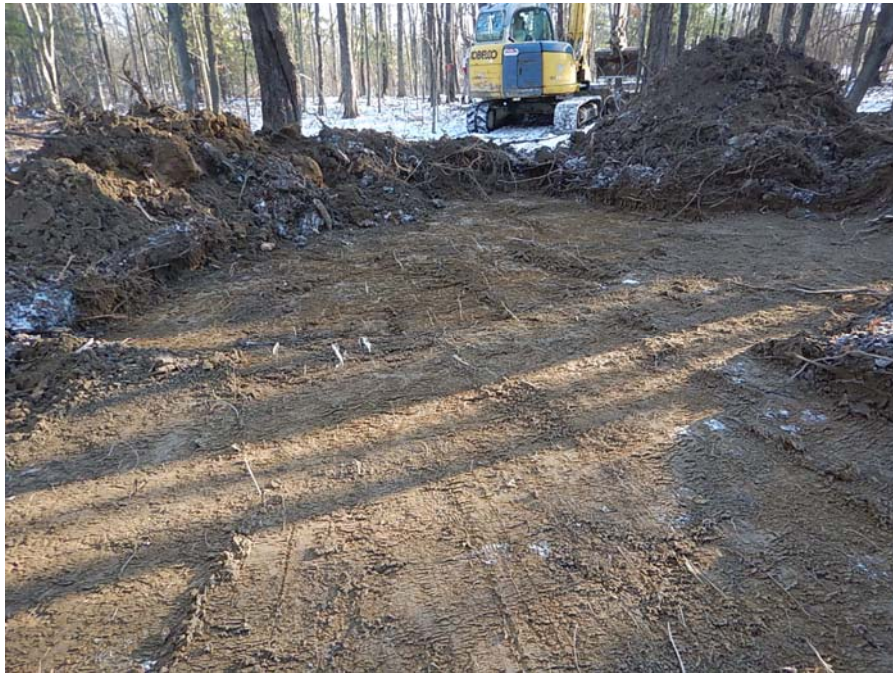
**Photo 5:** View northwest of Area 3 located within the central portion of the construction easement. New Rural Cemetery Concept Plan c. 1900 shows a cemetery road in this area. No burial shafts were encountered within the Stratum 2 subsoil during soil removal from the 10 by 10 meter area.

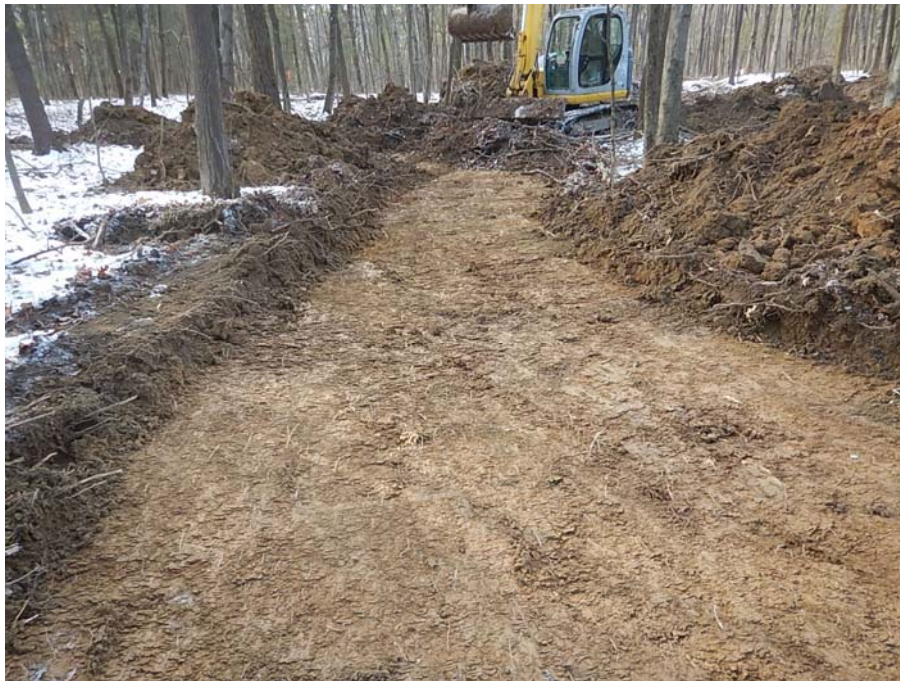
**Photo 6:** View north of Area 4 located within the central portion of the construction easement. The rectangular-shaped stripped area encompassing approximately 100 square meters lies near a cemetery road indicated on the New Rural Cemetery Concept Plan c. 1900. No burial shafts were identified.

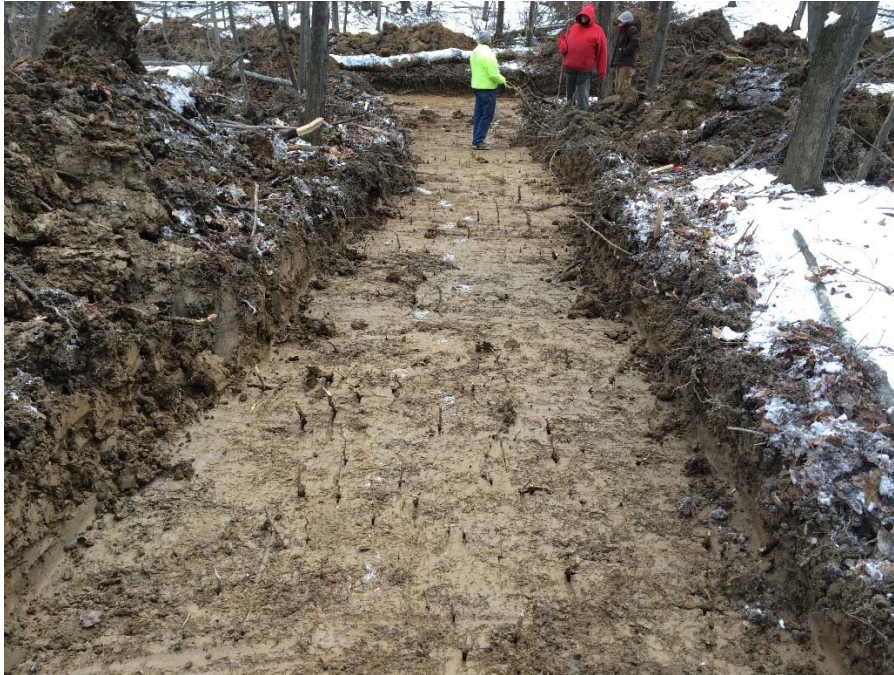
**Photo 7:** View southwest of Area 5 located within the south central portion of the construction easement. The 100 square meter stripped area lies adjacent to one of the cemetery roads that parallels a tributary to Mill Creek. No burial shafts were identified in Area 5.

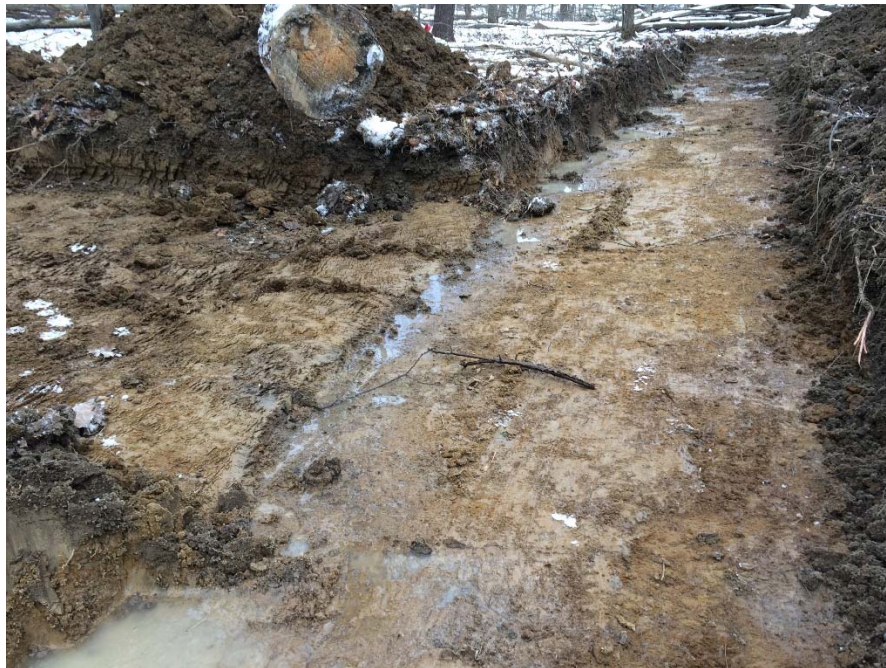
**Photo 8:** View south of Area 6 situated within the south central portion of the construction easement. The 100 square meter stripped area lies adjacent to one of the cemetery roads that parallels a tributary to Mill Creek. No burial shafts were identified.

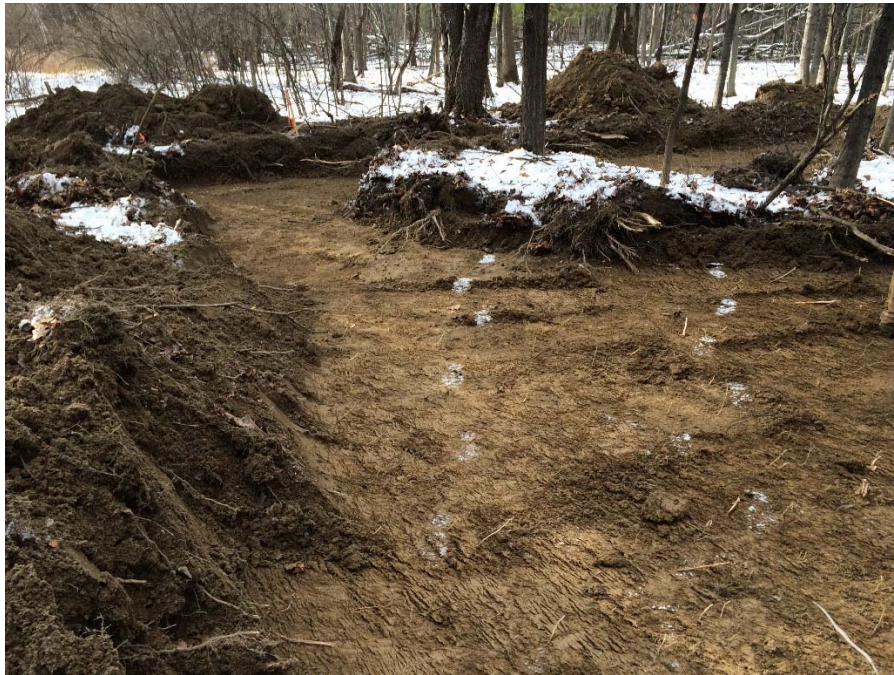
**Photo 9:** View south of Area 7 located at the southernmost end of the construction easement. The 100 square meter stripped area lies adjacent to the southernmost cemetery road shown on the New Rural Cemetery Concept Plan c. 1900. No burial shafts were identified.

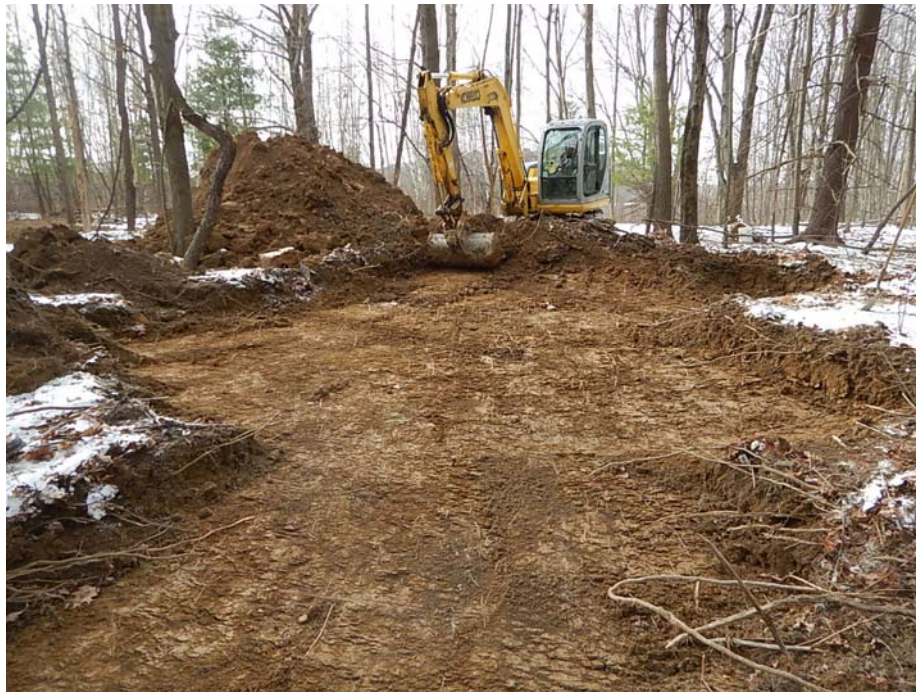
**Photo 10:** View north of Area 8 situated at the south end of the construction easement adjacent to the southernmost cemetery road indicated on the New Rural Cemetery Concept Plan c. 1900. No burial; shafts were identified within the 100 square meter area.

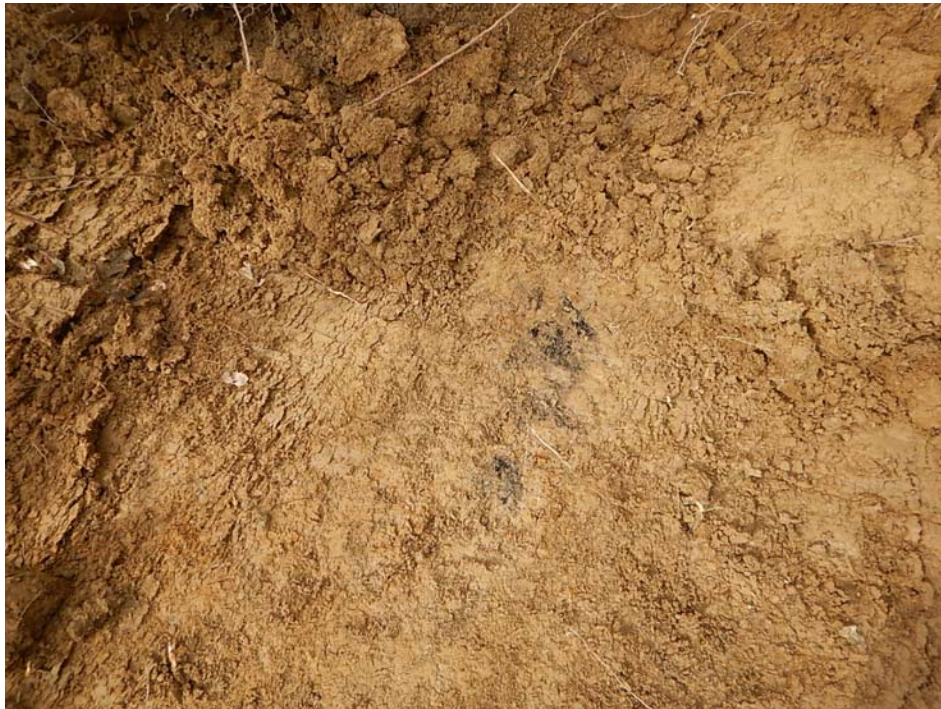
**Photo 11:** A small charcoal stain encountered within the southwest corner of Area 8. Further excavation determined it was the remnants of a burned tree root.

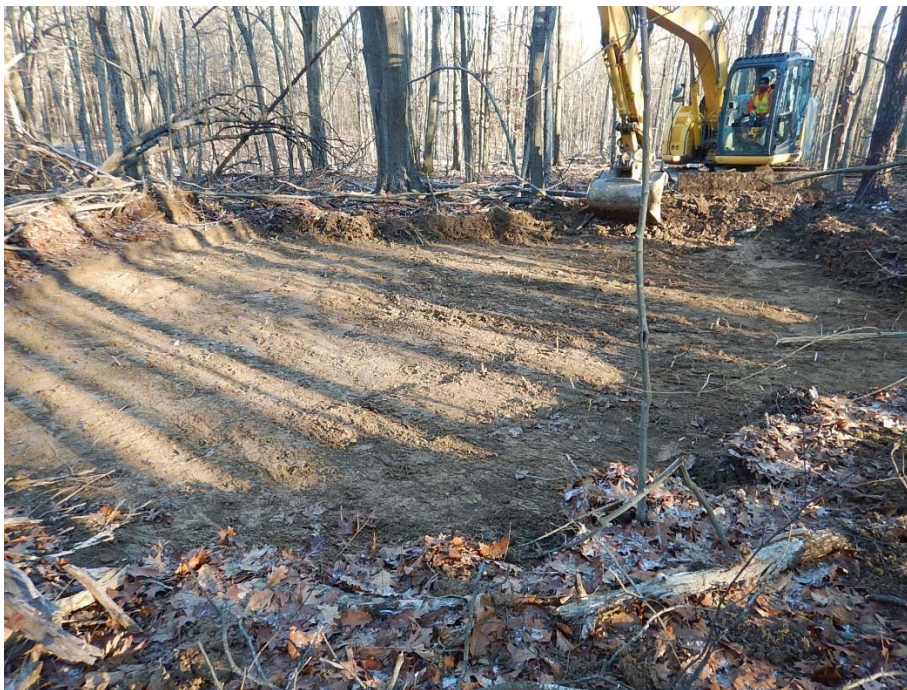
**Photo 14:** View south of Area 9 situated at the south end of the utility line corridor adjacent to the southernmost cemetery road indicated on the New Rural Cemetery Concept Plan c. 1900. No burial; shafts were identified within the 100 square meter area.

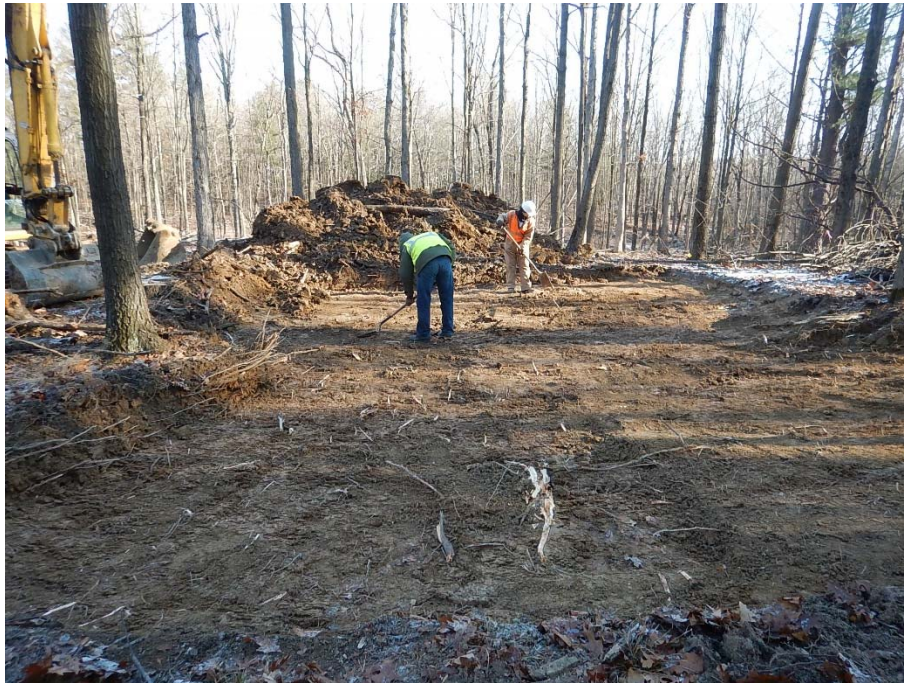
**Photo 15:** View northeast of Area 10 situated at the south end of the utility line corridor adjacent to the southernmost cemetery road indicated on the New Rural Cemetery Concept Plan c. 1900. No burial; shafts were identified within the 100 square meter area.

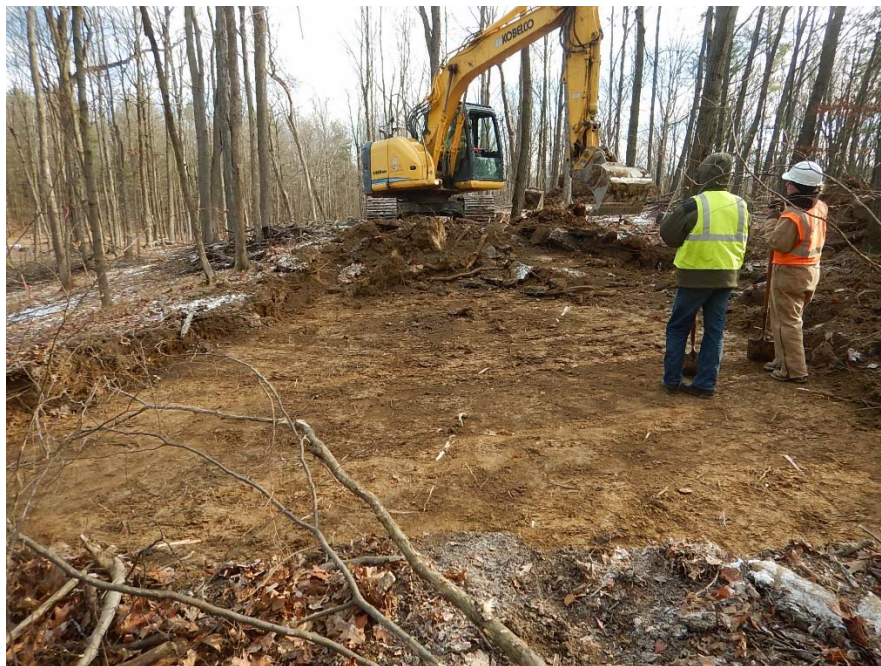
**Photo 16:** View east of Area 11 situated at the south end of the utility line corridor adjacent to the southernmost cemetery road indicated on the New Rural Cemetery Concept Plan c. 1900. No burial; shafts were identified within the 100 square meter area.

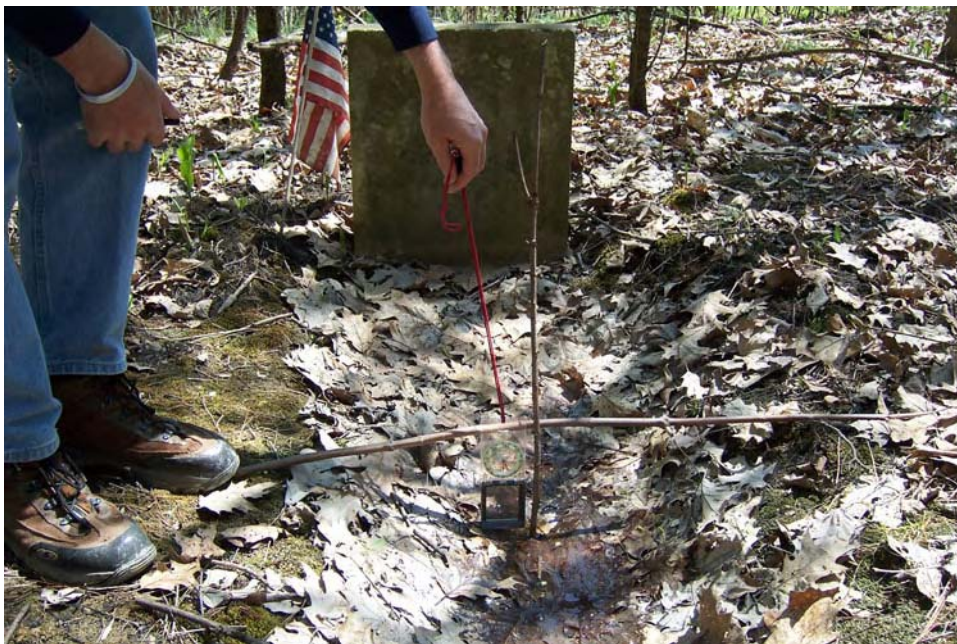
Photograph 2: Typical burial with headstone at RMSC Try 009, note depression and folding compass for scale (Compass from end of mirror to end of base plate is 6.8 in (17.3 cm). Depth of this depression is approximately 6.4 in (16.2 cm)

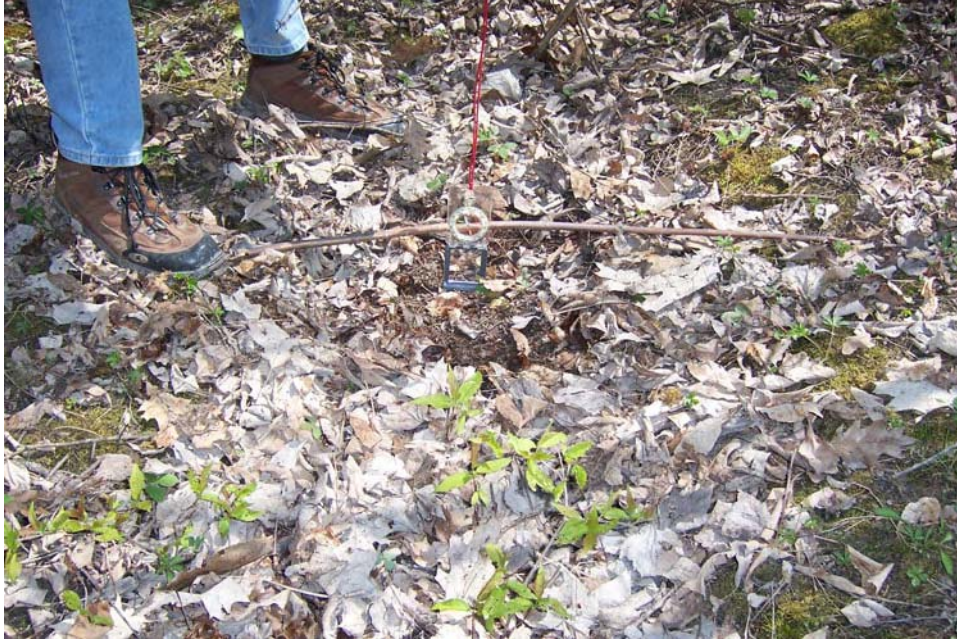
Photograph 3: Typical burial depression at RMSC Try 009 with compass for scale. Depth of this depression is approximately 4.5 in (11.4 cm).

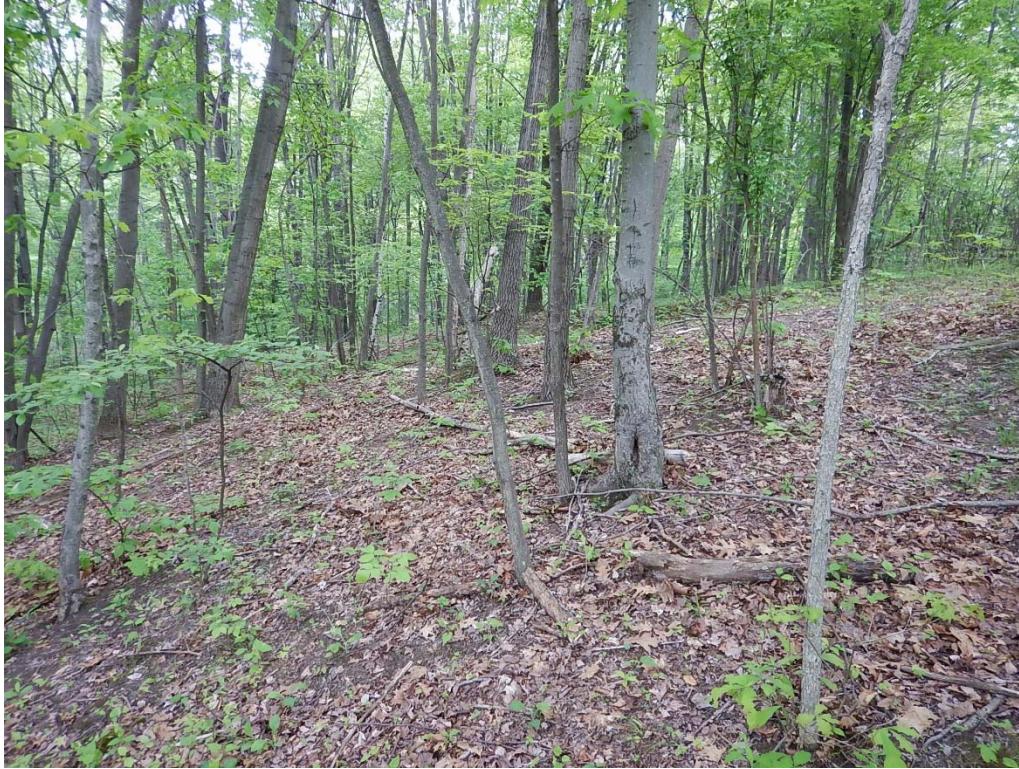
Photo 5. View northeast of the northwestern corner of the Project showing excessive slope. No testing was conducted in this area or other areas of similar slope.
