# ENGINEERS REPORT

Carver Court Subdivision  
Upper Mannix Road  
Town of East Greenbush  
State of New York

CLDZ LLC  
494 Western Turnpike  
Altamont, NY 12009

September 15, 2021

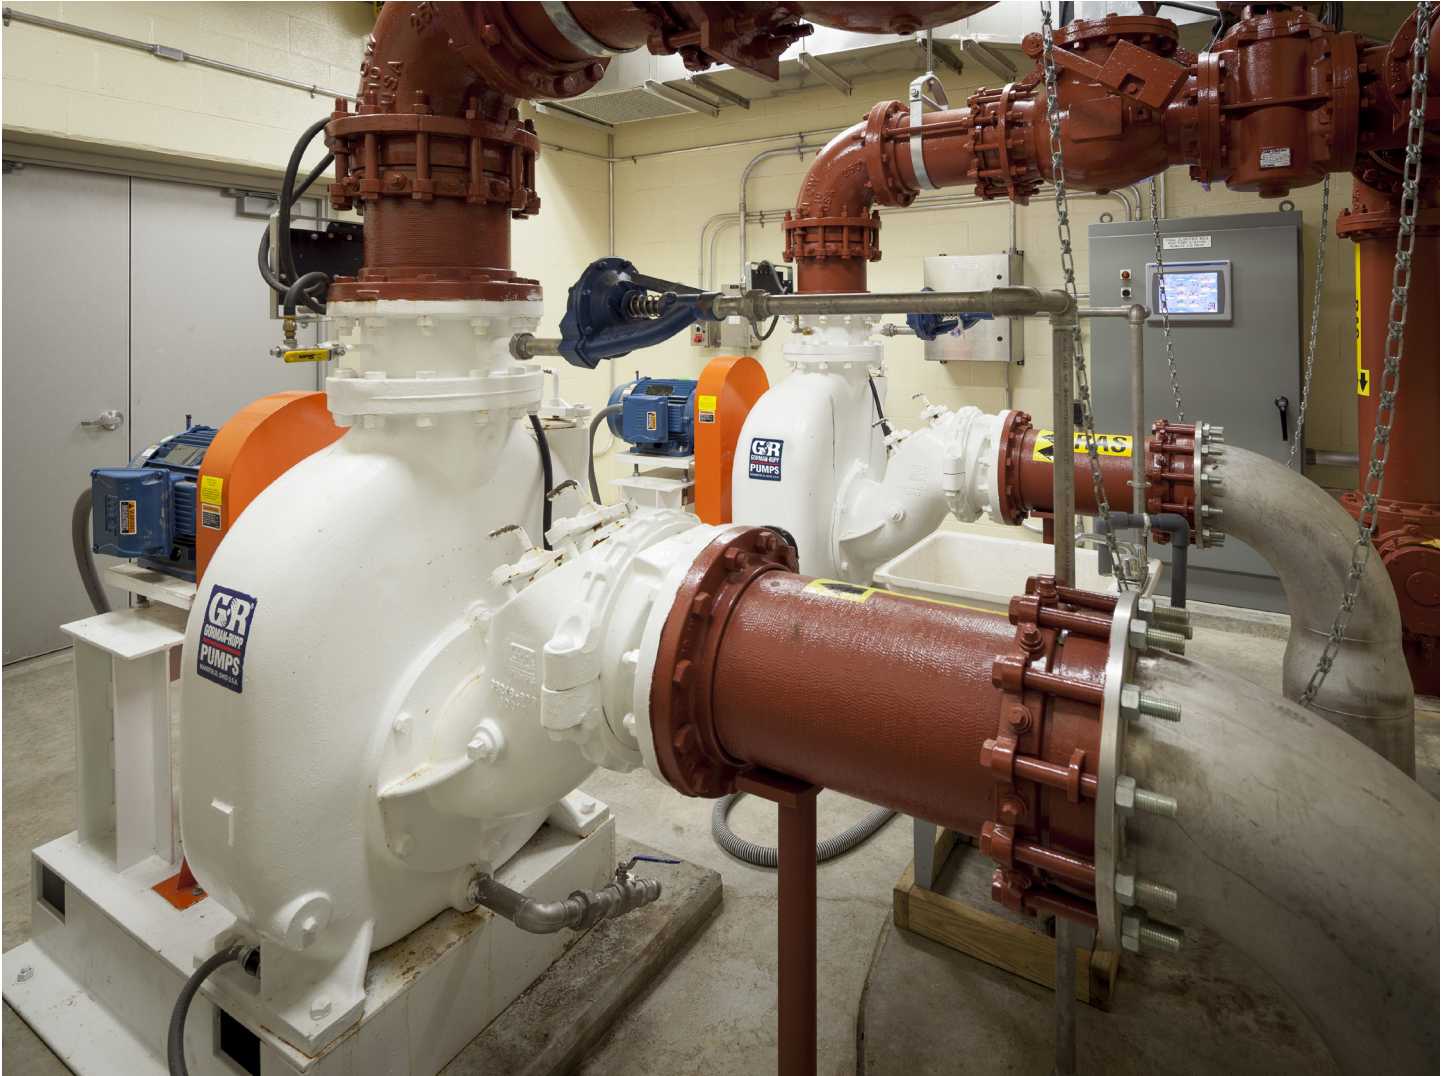
# HYDRAULIC ANALYSIS (CALCULATING TDH)

# CALCULATING TDH

In the simplest of terms, given a flow requirement (amount of liquid to move over a time period) and the location (point of discharge) to move that liquid to, a hydraulic analysis will be required to calculate the pressure required. Typically, to perform this we need to know a few basic site conditions including; the flow (GPM or l/s) the elevation of the liquid level in the sump or wet well, the elevation at the point of discharge along with details making up the piping network. Unless, completely downhill, to which the liquid will flow by gravity and no pump may be needed at all, there will be an amount of work that will be needed to move liquid to the point of discharge. This calculation is called a total dynamic head (TDH) calculation. A TDH calculation is comprised of two elements, static head and friction head.

Recalling the discussion of static head, the total static head (level in the wet well to the free point of discharge) is required for calculating the TDH. Depending on the type of installation desired, (above the liquid - aka: self-priming, dry pit- aka: standard centrifugal, or wet pit – aka: submersible), the individual portions of the static are handled differently.

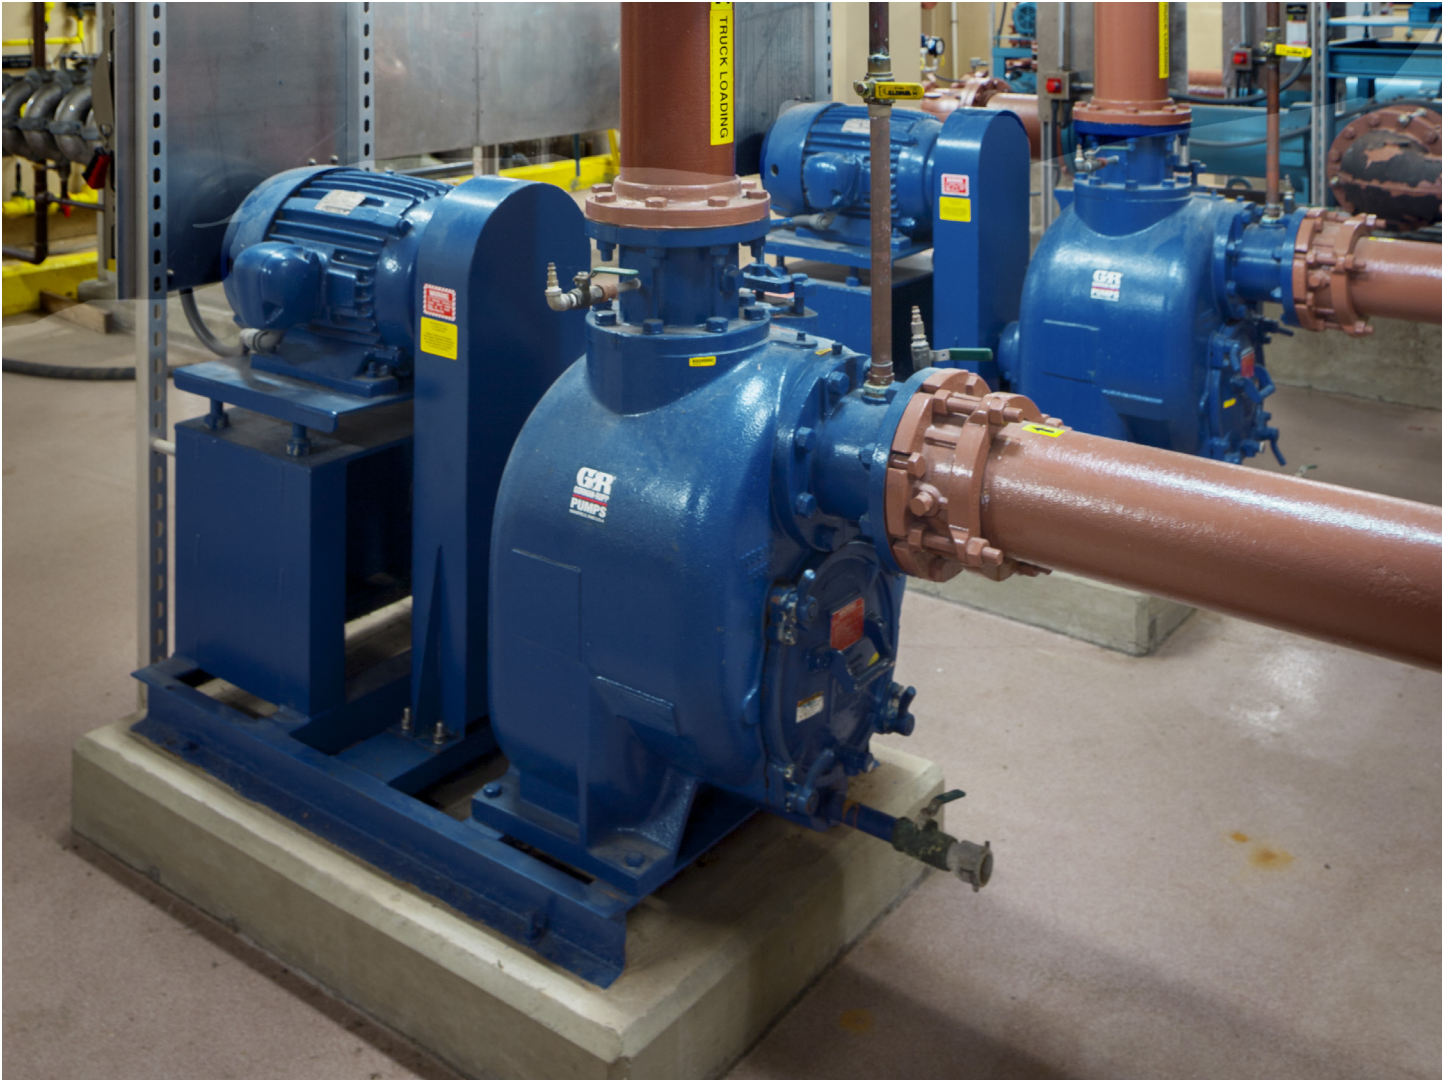
# SYSTEM HYDRAULICS (System Head Curve)

## System Head

Plot the system curve points (flow vs TDH) from the table on the previous page. Once plotted connect the points to establish the system curve for the system described. Can you answer the following?

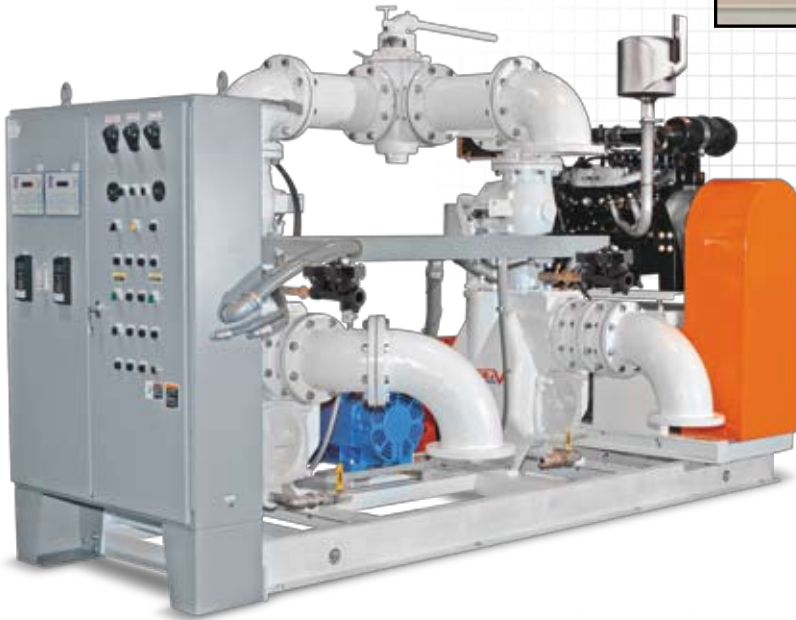
The Gorman-Rupp **Base Mounted Auto-Start** station uses a liquid level control which automatically converts to 12 volt DC and drives the pump with a standby engine providing normal pumping service during power failures. When power resumes, AC motor operation is automatically restored. It meets all standby requirements and uses a variety of fuels.

The Auto-Start unit is a space-saving, modular combination of pump, electric motor and engine, all coupled to the same drive, eliminating the need for an expensive engine/generator set.

The Gorman-Rupp base mounted auto-start lift station uses a 12V DC level control that drives the pump with a standby engine providing normal pumping service during power failures. When power resumes, electric motor operation is automatically restored. Meets all standby requirements and uses a variety of fuels. Gorman-Rupp base mounted pump stations are pre-engineered units with an extensive selection of pumps, motors, controls, piping and accessories. Gorman-Rupp has many standard designs for new installations, or we can custom design for existing installations with minimum hook-up time. Base mounted pump stations are available with 2", 3", 4", 6", 8" or 10" T Series or Super T Series pumps to match system requirements. For consistently heavy flows, a third or fourth pump may be added. Flows shown are for single pump operation. For high head/low flow, we offer standard staged designs.

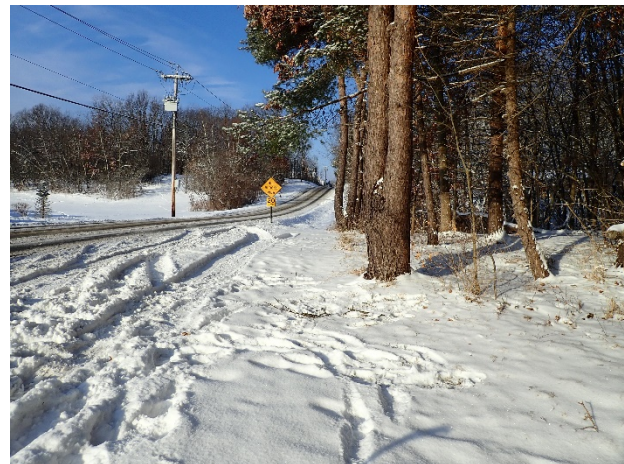
**Photograph 2: Looking right ( $D_R$ ) from proposed site access**

Table 4 shows that the sight distance looking straight for a vehicle turning left into the site and looking right to turn left out of the site satisfy the AASHTO recommended guidelines. The sight distance looking left for a vehicle to turn left or right out of the site is less than the AASHTO guidelines for the 50-mph westbound operating speed. The sight distance looking left is limited by a vertical curve in the roadway paired with a tree line on the parcel directly east of the project site, as shown in Photograph 1. Photograph 2 shows the clear line of sight looking right from the site access road.

The proposed site access is placed within the limited site frontage along Upper Mannix Road. To maximize the sight lines the following is recommended:
